Manhole Inspection Summary

Manhole # S09GG1012MH

Location Address: **3025 W COLD SPRING LANE** Cross Street: **WABASH AVE**

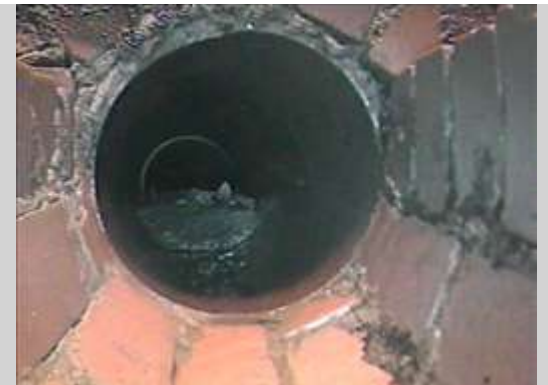
4 O'Clock Inflow

8 in. Circular Gravity Sewer
Pipe In @ 4 O'Clock

Invert Depth: **9.00** (ft.) Flow Characteristics: **Slow**

Deposits: ☒ **None** ☐ Mud ☐ Sludge ☐ Debris ☐ Grease

Infiltration: **None** Pipe Seal Cond: **Sound**

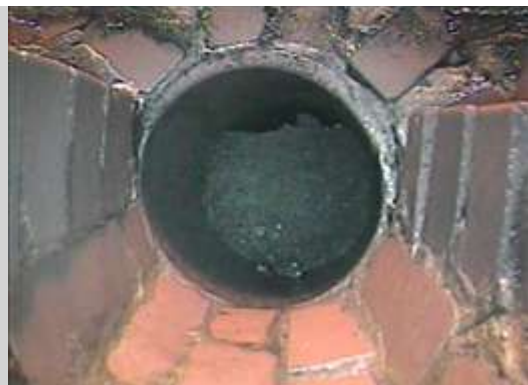
8 O'Clock Inflow

8 in. Circular Gravity Sewer
Pipe In @ 8 O'Clock

Infiltration: **None**
